Manhole Inspection Summary

Manhole # S37EE_058MH

Insp Date: **1/16/08 2:13 PM**

Location Address: **1131 GREENMOUNT AVE**

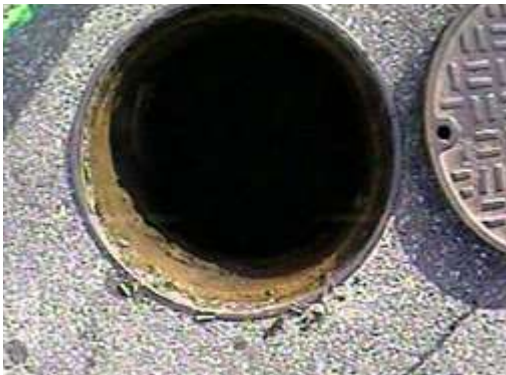
Top View

Offset: **3** (in.)

FRAME OFFSET

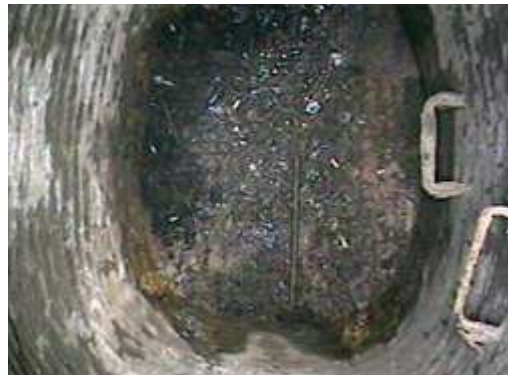
Defect 2

Count: **4** Missing: **2** ☒ **Corroded**

CORRODED STEPS

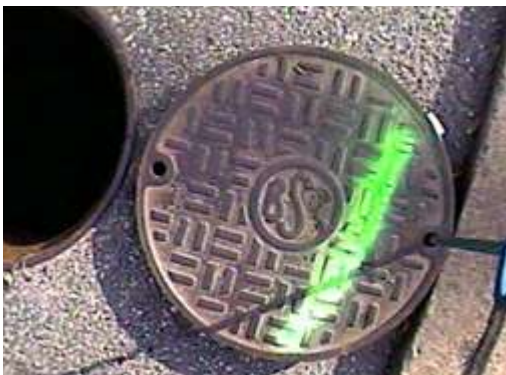
Defect 1

Condition: **Cracked**

COVER CRACKED WHERE GREEN LINE IS.

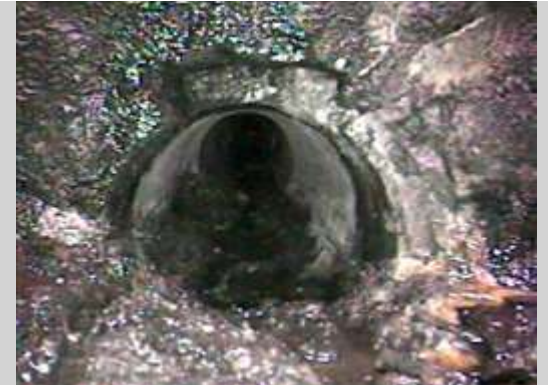
12 O'Clock Outflow

PIPE SEAL BAD - BROKEN

Infiltration: **Evidence** Pipe Seal Cond: **Broken**
